A CULTURAL HERITAGE IMPACT STATEMENT

Bradley/Craig Barn Demolition & Relocation
590 Hazeldean Road, Ottawa

Prepared By:
COMMONWEALTH RESOURCE MANAGEMENT
September 2015

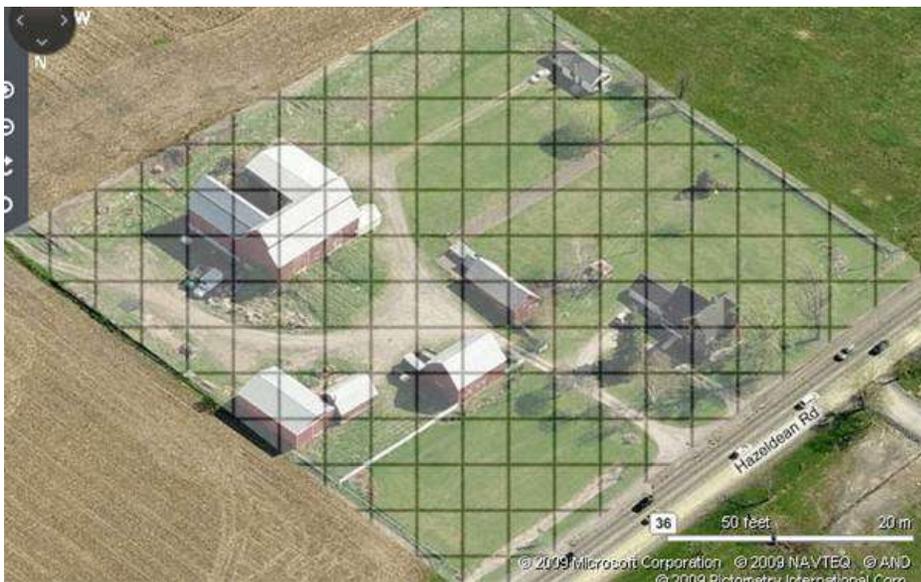
Figure 3: Overall aerial view of the 4-acre farmstead off Hazeldean Road the hatching indicates the area designated as a heritage site, including house and Barn. The collection of outbuildings ringing the barn has been demolished. Credit: Bing Maps.

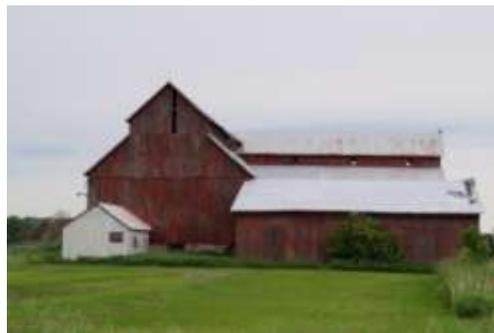
Figure 6: View of the barn looking east

Description of Barn

The barn is described as a 'bank barn' with double ramp and the roof ridge running east to west. The superstructure is post and beam timber construction with a gable roof, which includes a monitor for added ventilation. The barn complex is 'U' shaped with the rear section on the southeast side built a few years after the original barn was completed. The building forming the south west side was initially log and was probably earlier than the bank barn. At some point, it was removed. A recently constructed implement garage replaced it. Built as a dairy barn with hay storage above the ground floor, the barn is considered to be an excellently preserved example of large timber frame construction. It appeared that some of the material used in the construction of the barn was reused from what may have been the original farm buildings of log construction¹.

The barn is a two storey L shape with coursed stone masonry foundation; two earth ramps lead up to two large double doors on the north elevation providing access to the upper level. The lower level of the barn contains a two bay milking parlour and stables while the upper level has a threshing floor with storage areas to the sides. The interior spaces of the upper level has a beautiful skeletal, almost ecclesiastical feeling, with light entering through the spaced vertical cladding boards. The symmetry and rhythm of rough-hewn and round pole framing members provide a sense of order and enclosure in the large voluminous space. The storage area includes hay mows accessed by wood ladders built into the structure.

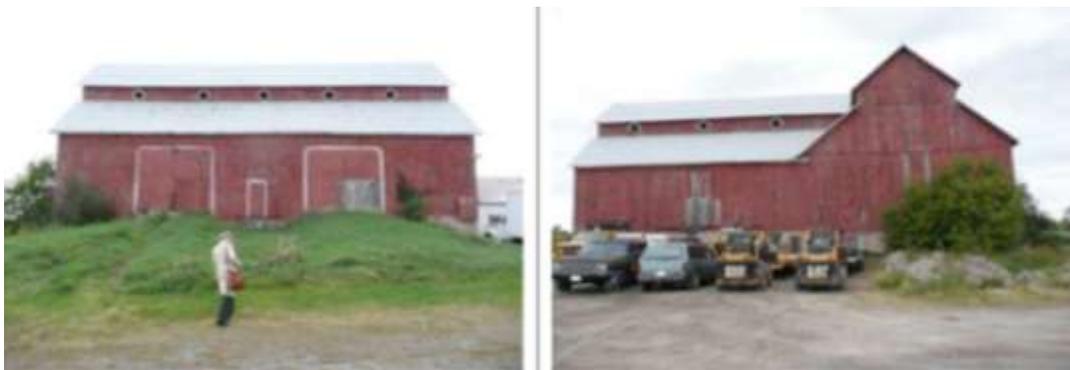
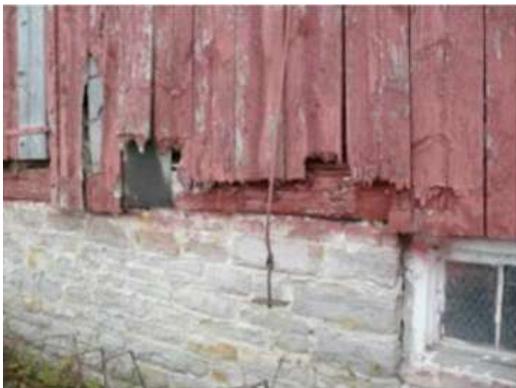
Figure 7, 8, and 9: provide views of the north and west elevations with a detail view of the masonry foundation.

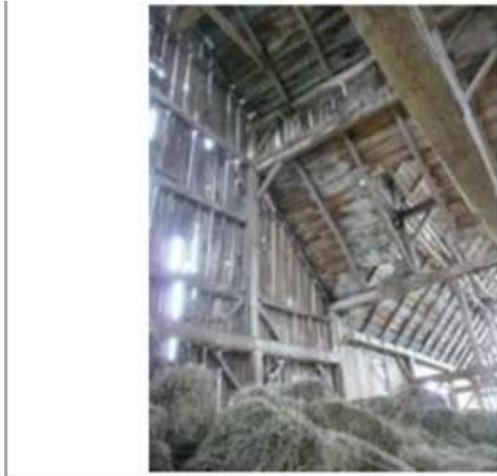
Photo 9: Barn interior looking southeast.

Figure 10: A montage of pictures numbered 9, 10, 15, 16, 17, and 18 are from Building Condition Brief recording the existing condition of the barn. Credit: Robertson Martin Architects.

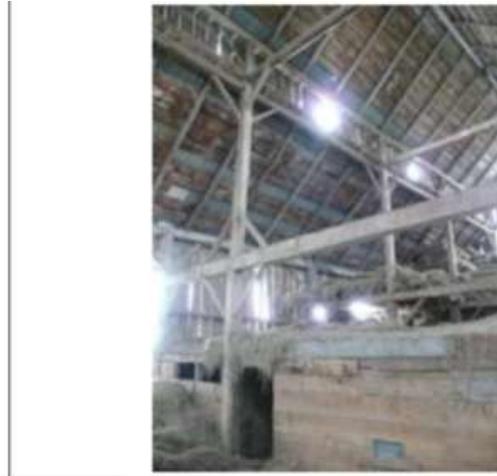
Photo 10: Barn interior looking southwest.

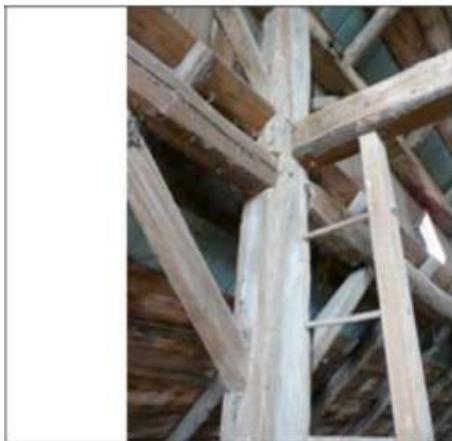
Photo 15: Structural joinery and ladder.

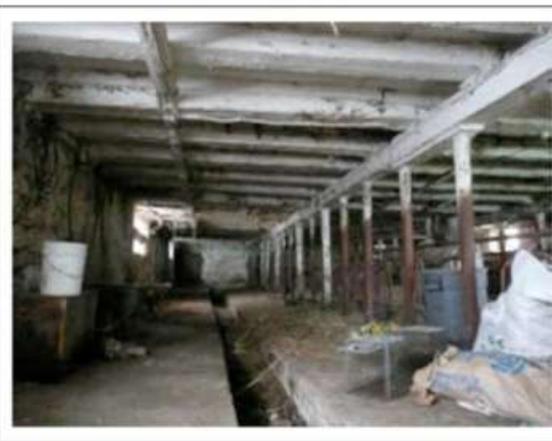
Photo 16: Barn lower stall area. Note manure removal system.

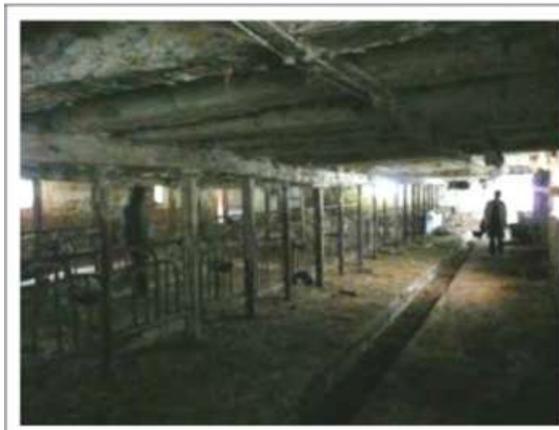
Photo 17: Barn lower stall area. Note manure removal system.

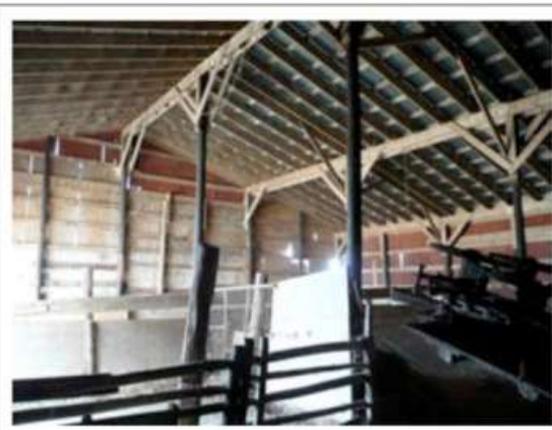
Photo 18: Southwest addition. Note contemporary detailing.

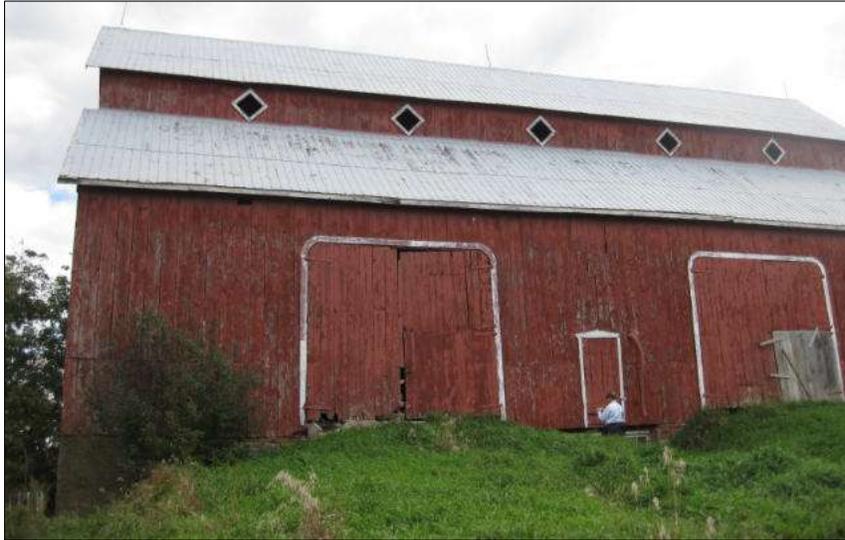
Figure 12: Bradley/Craig Barn north elevation showing earth mounds leading to double doors with a centre man door, monitor roof line, wood cladding, and diamond-shaped clerestory windows.

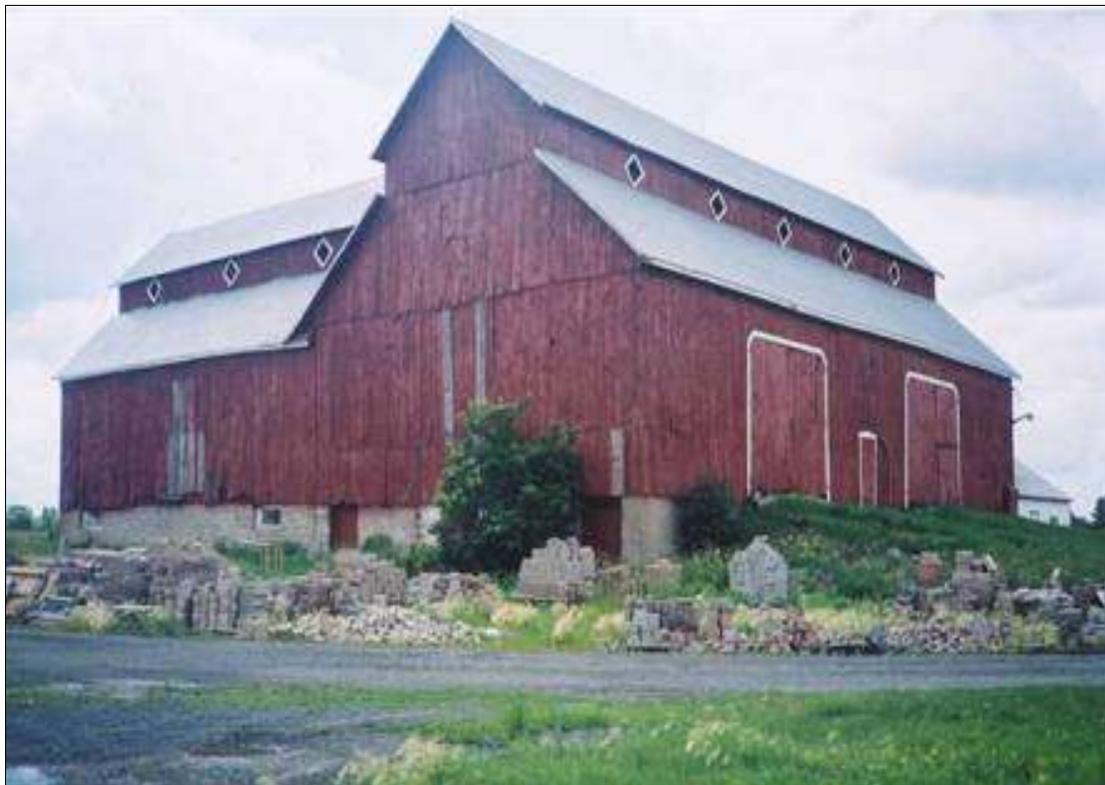
Figure 13: Northeast Elevation of the Bradley/Craig Barn in 2003. This view shows the extension, monitor roof lines, stone foundation, wood cladding, diamond-shaped clerestory windows, and raised two-bay barn plan. This is an important contextual view establishing the scale of the barn and the manner, in which it is situated. Credit: Carol Ruddy and City of Ottawa Designation Report.

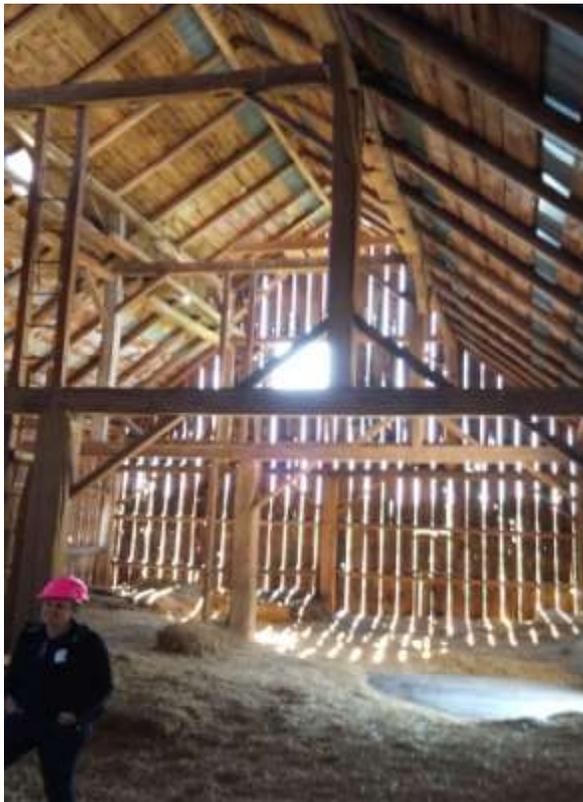
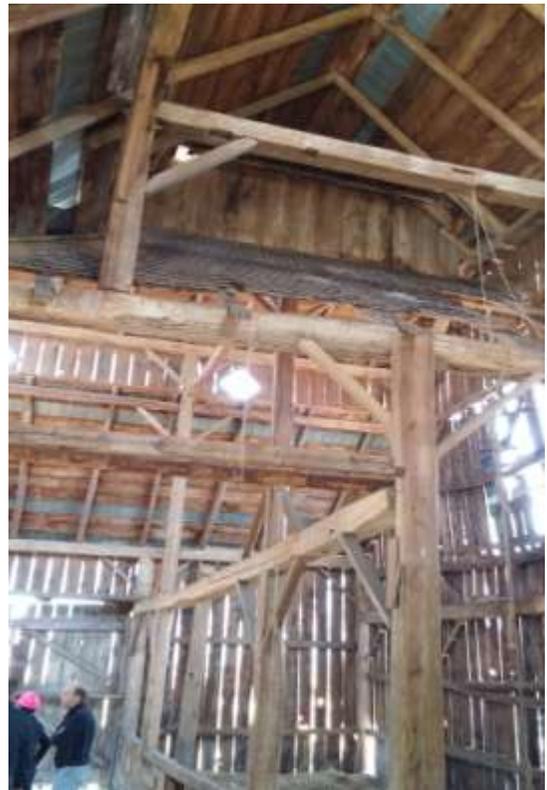
Figures 14, and 15: Interior views of the barn 2015. "Gaps between barn boards are not the result of carelessness but were deliberately included to provide for air circulation. They also admitted filter light and an empty barn in June just before the first hay is garnered, can inspire thoughts of medieval castles²." Figure 16: The view of the lower level tail documents a slightly smaller footprint that served as the nursery for calves, the bull, and work horses. Credit: Commonwealth/Richcraft

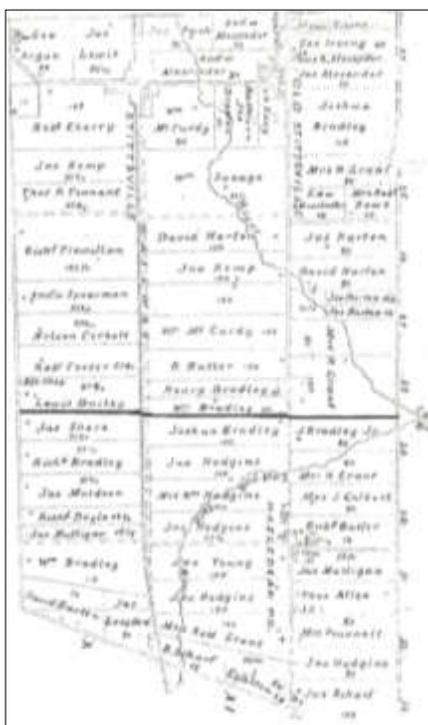
Figure 19: The 1823 survey locating land holdings determined the overall land pattern throughout Ontario. Within the individual rectangle, a format for organizing the farm lands was established.

Joshua and Jacob Bradley each received their own Crown land grant in Goulbourn Township and like most settlers, organized their farm according to a prescribed format. Buildings making up the farm core were located closest to the road with agricultural fields organized into a well-established layout pattern, separated by fencing, centred on the farm lane that linked the back fields and the farm core to the public road. Each of the fields was fenced to control access. Trees and shrubs were allowed to grow along these fence rows, creating a border to each field. The house and barn along with multiple secondary structures defined the farm core area. Planted trees such as sugar maple, poplar and Norway spruce delineated boundaries and provided wind breaks. The orchard and gardens were located in the core area and were traditionally the domain of the female members of the family. Today, throughout many parts of the county, tree lines and remnant, old orchard trees are the remaining evidence of an all-pervasive former landscape.

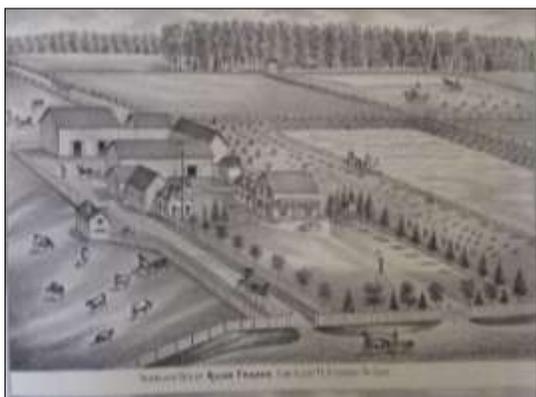
Figure 20: An example of farm layout from the Carlton County Atlas. The farm was an extremely efficient model of pragmatism that evolved from experience and the forced land pattern of the grid system survey. It created a distinctive layout and division of the farm into a series of fenced fields, a small managed woodlot for fuel and timber, a farmstead core dominated by a large timber barn for the farm animals, hay, and grain storage, numerous outbuildings, and a spacious farmhouse surrounded by gardens and an orchard. Credit: Historical Atlas, Belden & Co.

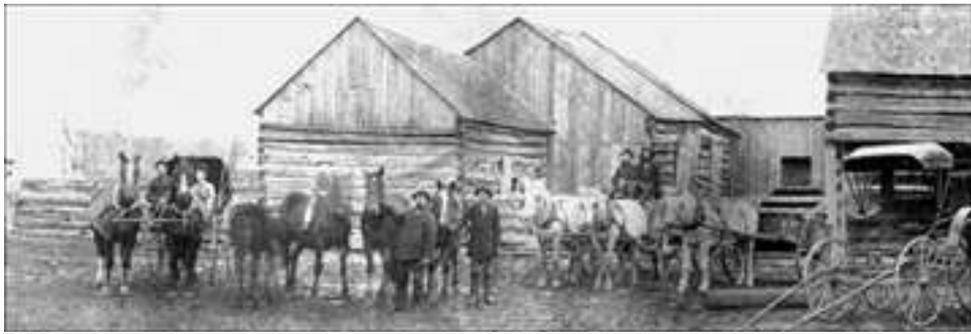
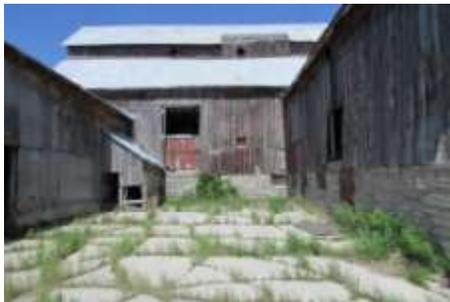
Figure 21: and Figure 22: The two pictures taken of the rear of the Bradley/Craig barn document the U shape building with courtyard. . The photograph, taken in the early 1890s, apparently on the same day as the old photograph showing the house, indicates the log wings extending back. The monitor is not apparent nor is the timber frame addition, which was supposed to be added soon after the construction of the 1873 main barn. In the background, the farmhouse is visible.

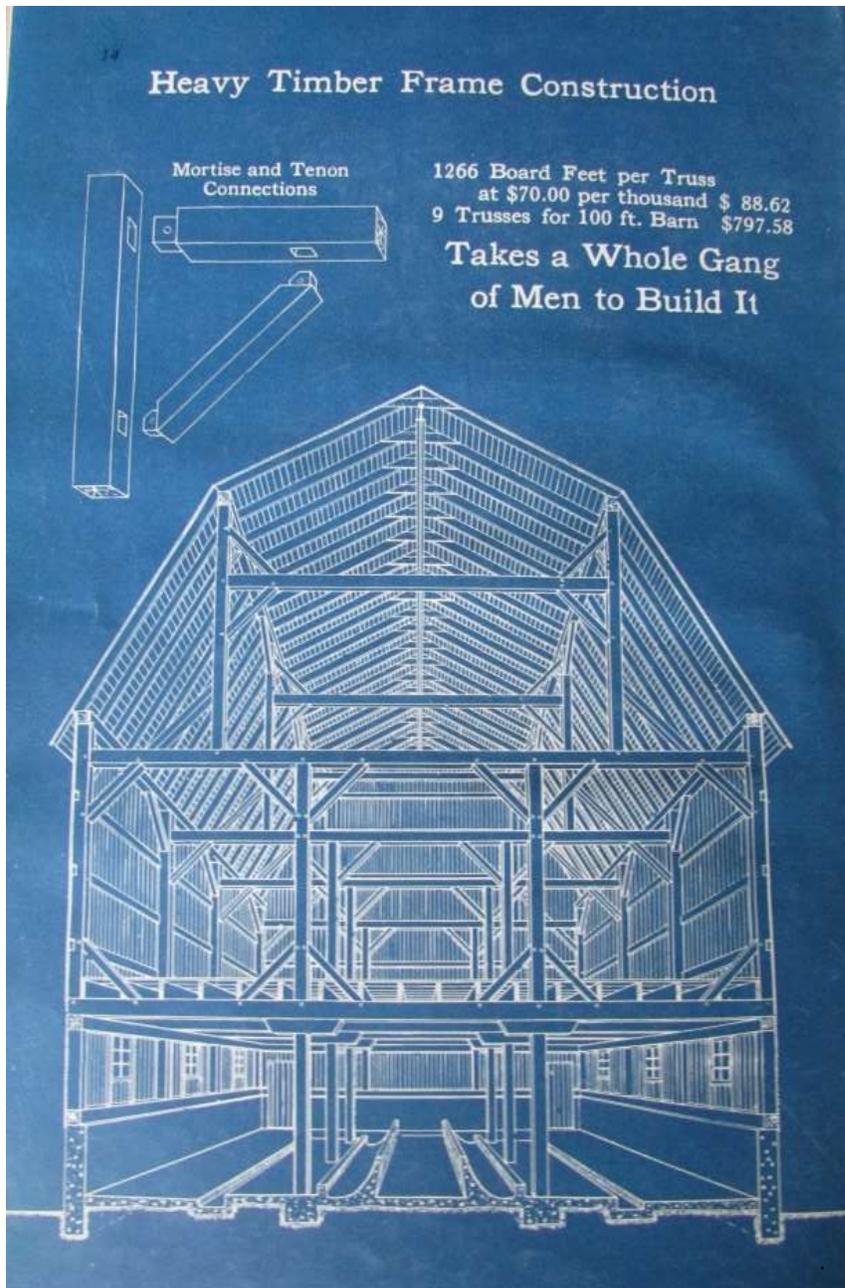
Figure 24: Illustrates heavy-timber frame construction with the milking chamber in the lower level and the upper level intended for storage of grain and hay. The width of the barn was determined by the milking stalls and the ability to access and service the dairy herd. Credit: BT Barn Book.

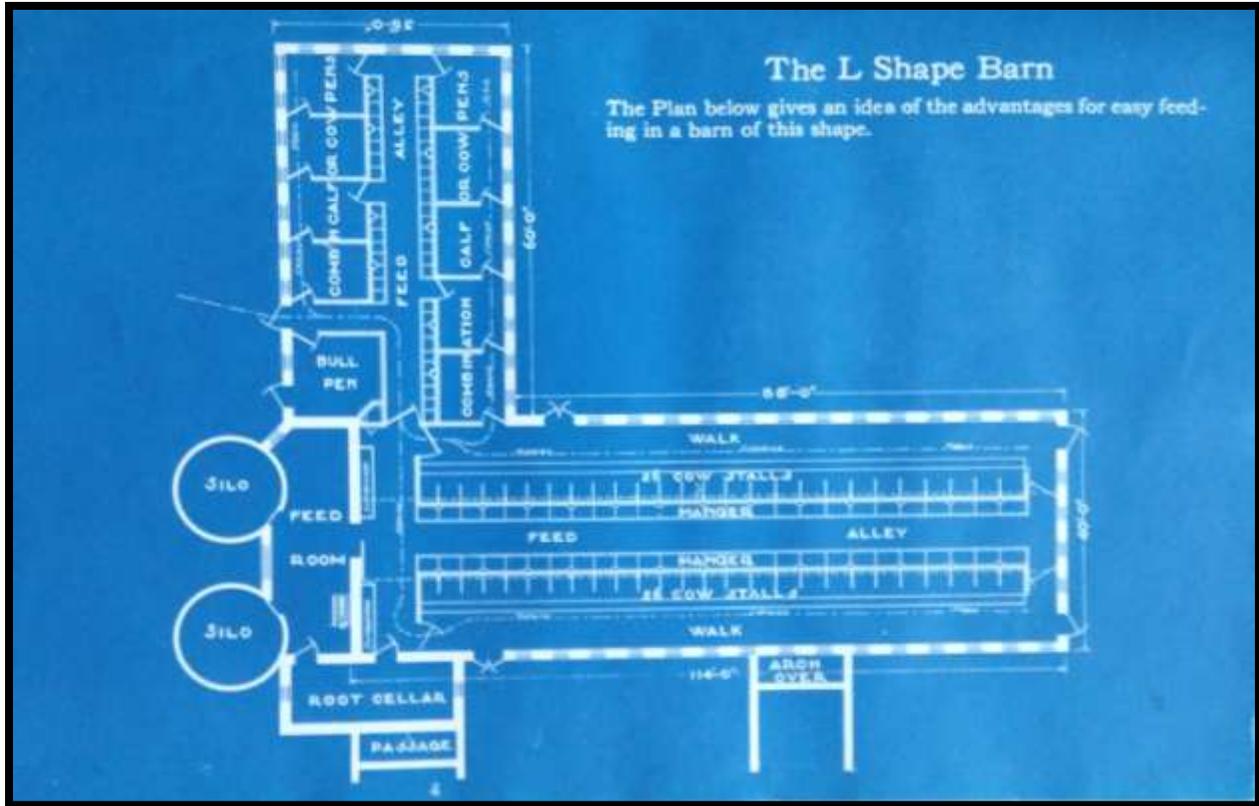
Figure 25: The L-shaped Barn of A. H. Fair in Kingston, Ontario is an almost identical layout to the Bradley/Craig Barn with the exceptions of the silos. Dimensions were standardized to permit the room for the cow stalls with feeding alleys. The tail is slightly smaller and served as the nursery for calves, the bull, and work horses. credit: BT Barn Book Fergus, Ontario. nd.

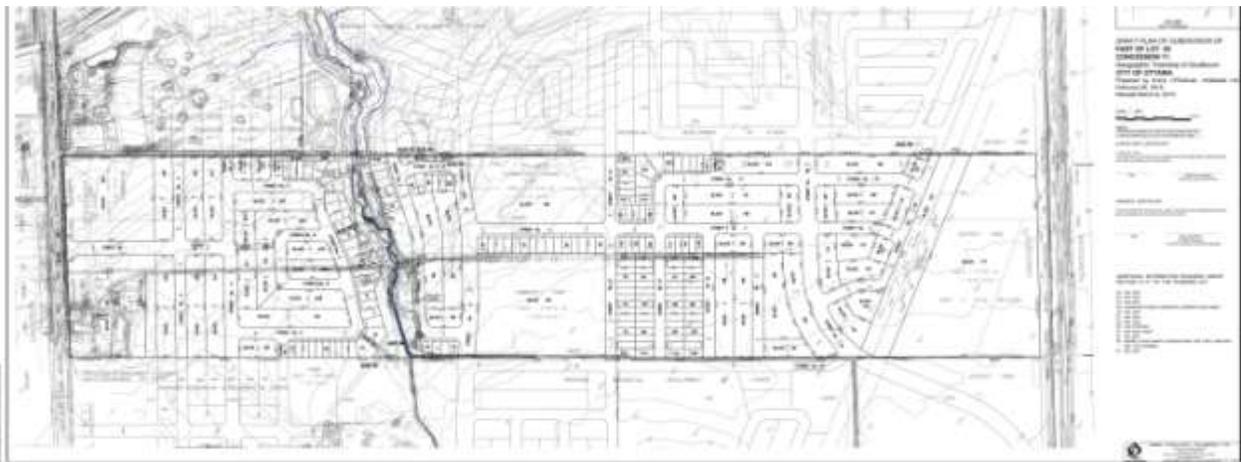
Figure 26: The proposed plan of subdivision for the Craig lands extends south from Hazeldean Road. The lands adjacent to the road in orange are intended for commercial development similar to what is across the road at the 550- 559Hazeldean Road. The plan includes the adjacent properties to the northeast and southwest, (shown in grey and located on the top and bottom of this Figure) which will incorporate lands both east and west as part of the subdivision. Credit: Fotenn 2015.

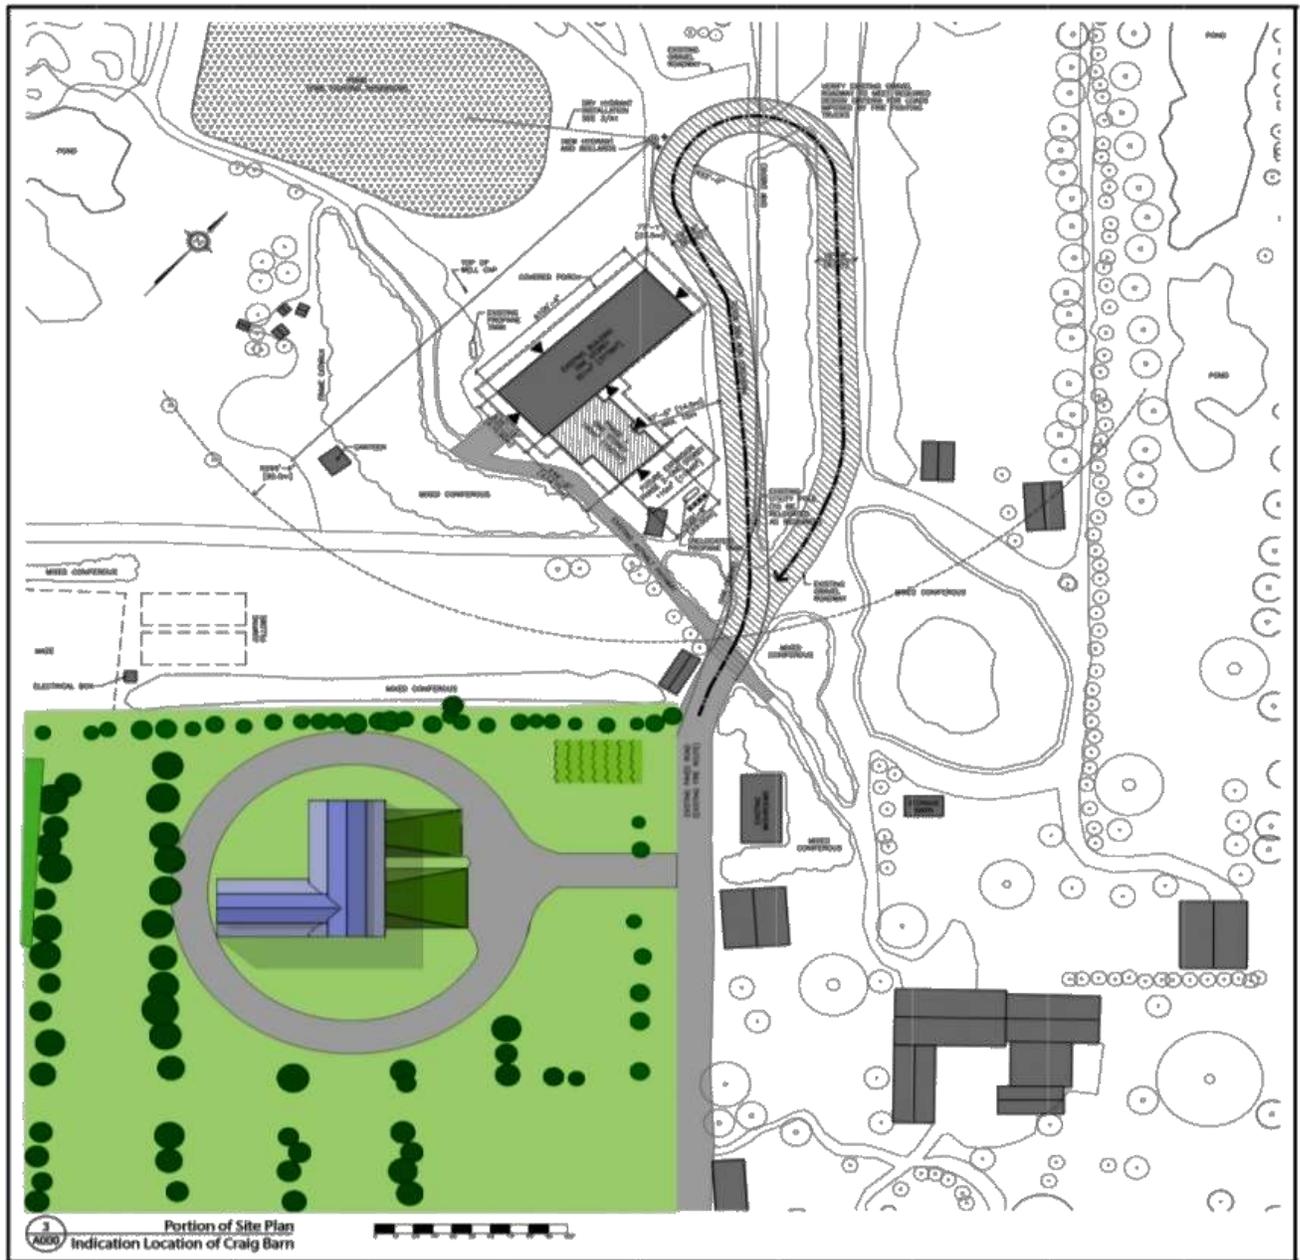
Figure 28: A site plan of a portion of the Saunders Farm showing the placement of existing buildings and their relationship to the proposed barn. The collection of small buildings next to the road is suggestive of the utility buildings that were ringed around the barn at the Hazeldean site. The circular drive around the barn reinterprets an original feature.

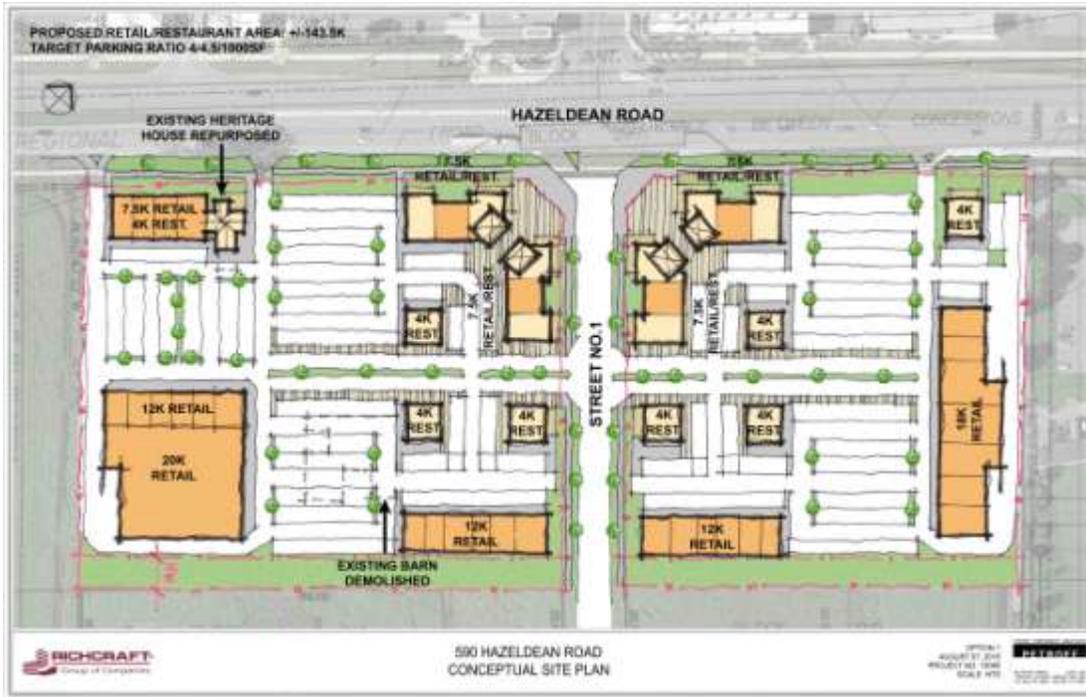
Option 1

The three options prepared by Petroff provide context and illustrate the development intent.

It is recommended that the link connecting the house to the new retail as shown on all three options (Appendix A) be more carefully considered. Also, around the house a green space buffer be established with some interpretation. Such a space will help distinguish the house from the new build and support the interpretation of the area's rural history.

The three options prepared by Petroff (APPENDIX A) fail to acknowledge the value of the house and its relationship to its environment. The location of the proposed new retail is set proud of the house, closer to the street and blocking views of the house. Another concern is the way the retail is connected with the new addition butting into the house. The lack of any form of buffer around the house will have a negative impact as does the lack of an interpretative plan.
